PISCATAQUA RIVER BASIN  
NOTTINGHAM, NEW HAMPSHIRE

GOVE DIKE  
NH 00135

PHASE I INSPECTION REPORT  
NATIONAL DAM INSPECTION PROGRAM

JULY 1978

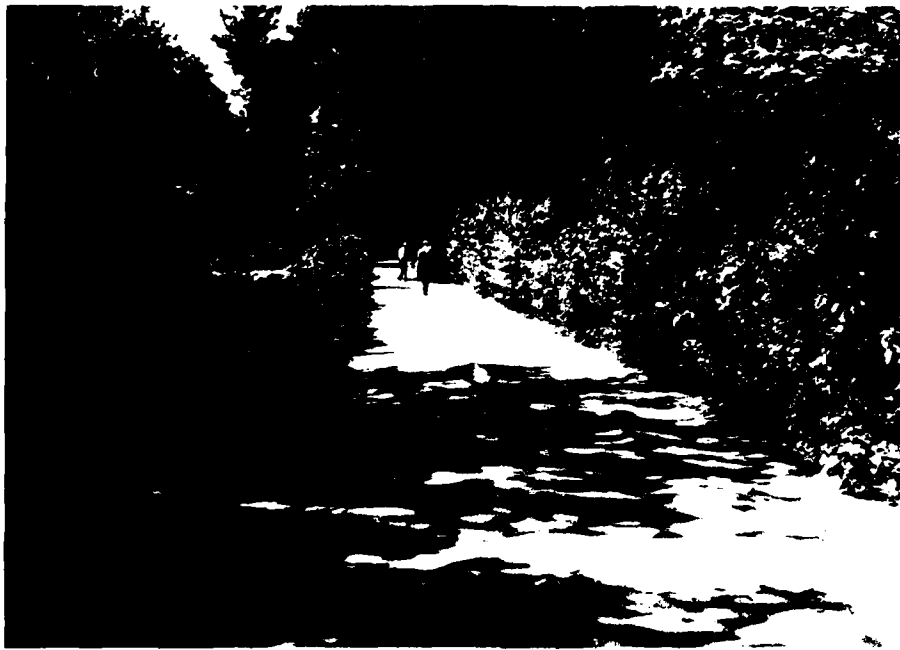
Figure 4 - Looking west along the center of the dike from the east abutment.
